Leakage in clutch servo 970 051 412 0

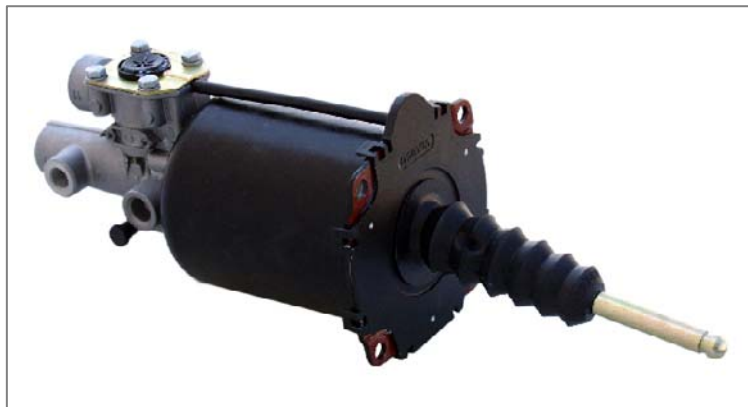
In MAN vehicle models TGA, TGS, TGX, Cityliner, Tourliner, Trendliner, Lion's Coach, Lion's Regio and Omnibus, leakages may occur when the clutch is replaced. Fluid from the hydraulic operating valve may then escape from a ventilation bore in the clutch servo.

This situation only occurs where there is a poor combination of tolerances between the flywheel, clutch disc and pressure plate. When the clutch pedal is activated, the clutch servo tappet is operated outside of its specified stroke range. This causes the piston valve seal to fail.

Clutch servo 970 051 466 0 should be installed to remedy this. This unit has a longer tappet that does not operate outside of the permitted stroke range even in the above situation.
